The Chicago School Fire

By Chester I. Babcock, Manager and Rexford Wilson, Engineer

NFPA Fire Record Department

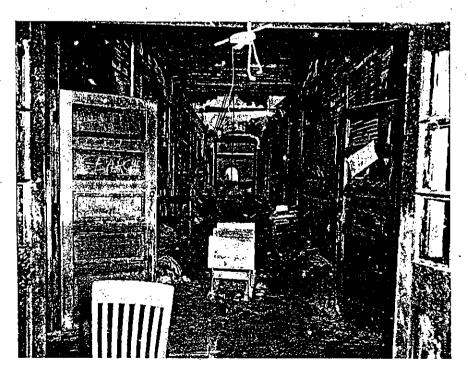
View of second story corridor of north wing, looking from front stairway landing. Fire originated in rear stairway beyond the arch in center background of photo. Door to Room 212 is at left foreground.

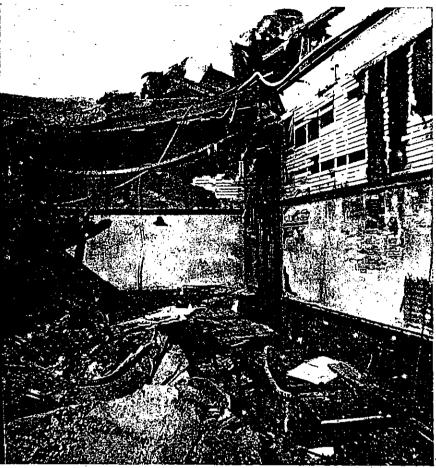
The quick-thinking teacher of Room 209, who took firm control of her class, had much to do with the fact that only one child died in this room. Note the vacant spaces on the walls that had been filled with highly combustible pressed paperboard blackboards.

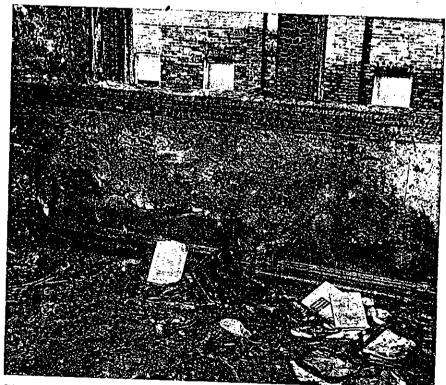
Many of the fourth graders in Room 210 died beneath these double windows. Height of windows above floor 37% inches.

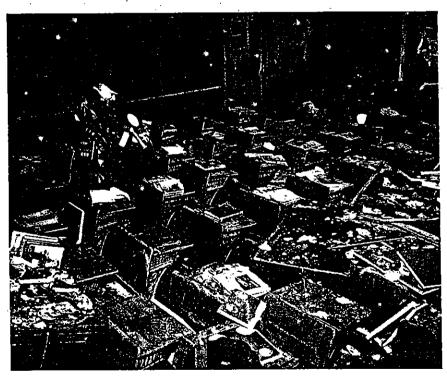
Room 212, located farthest from and least damaged by the fire, sustained the greatest number of casualties. Note the congestion of desks. The heavy smoke conditions are indicated by the dark color of the walls under the blackboards and by smoke-free spots on the desks.

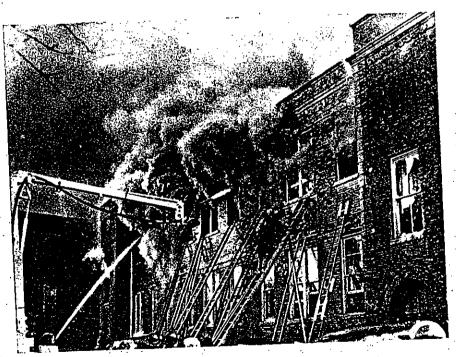
Many children were taken down fire department ladders before they were asphyxiated or burned to death. When this picture was taken those still in the building were dead. A new type of fire department apparatus used experimentally by the Chicago Fire Department and known as the Pilman "giraffe" is shown in use.

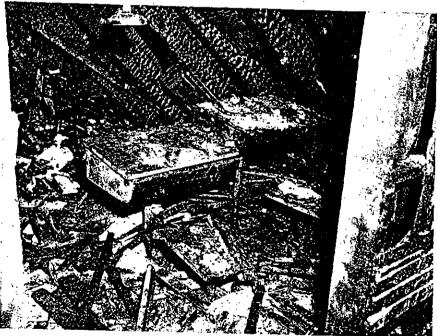
A view of Room 208, taken from a wall opening chopped by a rescue squad. The roof over the room had collapsed. Note heavily burned ceiling tile in the debris.
